Mine Name: Indian Queen Marble

Inspection Report Minerals Regulatory Program

Permit Number: M/001/0019

Inspection Date: 07-22-2008

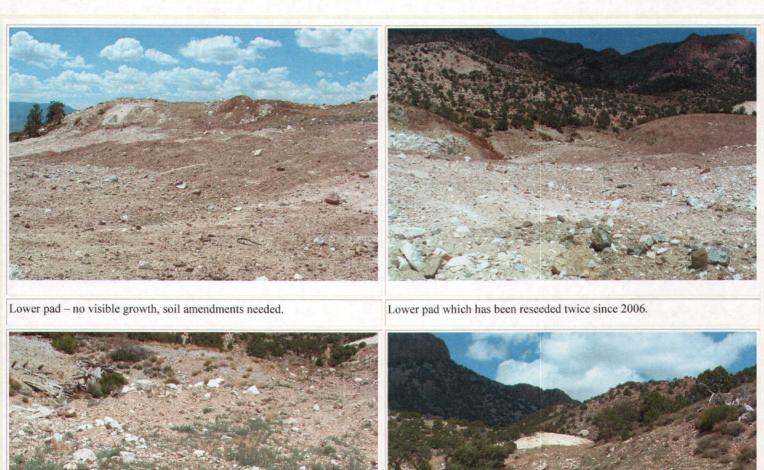
The lower road section between upper and lower pads has mostly halogeton. Good plants farther up the road between the upper and lower pads.
